Transverse patellar fracture fixation with tape cerclage in a patient with a history of complicated contralateral patellar fracture fixation with metallic hardware

La Sapienza University of Rome, Department of Orthopaedics, Sant'Andrea Hospital, Rome, Italy

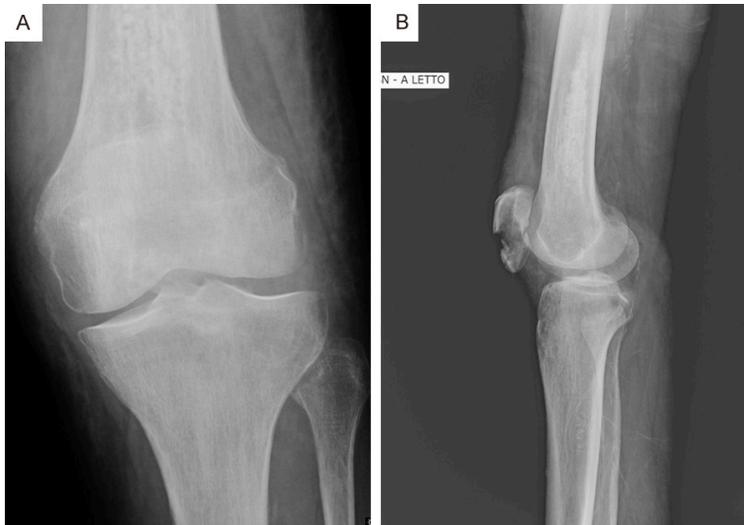
Figure 1. Pre-operative x ray showing displaced transverse fracture (AO/OTA 34C1.3) of the left patella. A. AP view. B. Lateral view.

The X-rays showed a displaced transverse fracture (AO/OTA 34C1.3) of the left patella (**Figure 1A, 1B**).

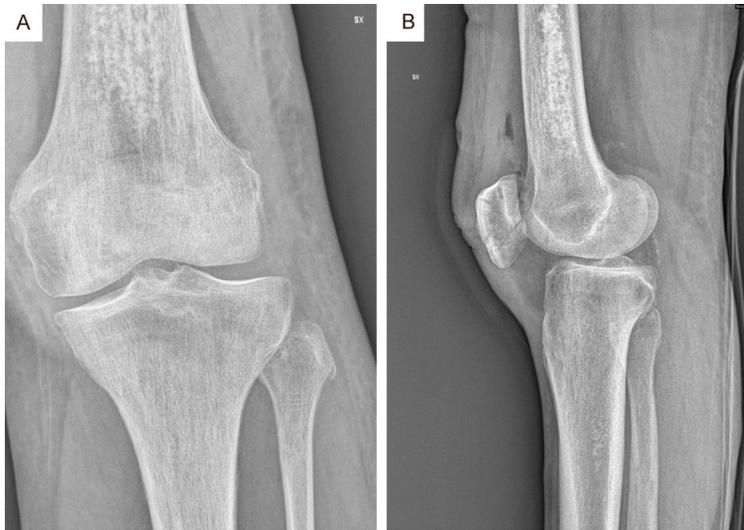
Figure 2. Immediate post-operative X-rays. A. AP view. B. Lateral view.

A transverse skin incision of 10 cm on the knee was made to expose the fracture. The fracture site was cleared using curettage and irrigation. A temporary reduction of the fracture was obtained using the clamps and checked under fluoroscopy. A 2.4 mm eyelet Kirschner wire (K-wire) was passed with a conventional drill into the upper pole of the patellar bone from lateral to medial. A straight blunt Deschamps needle was passed under the patellar tendon from medial to lateral, to obtain a circumferential loop, and the FiberTape was passed deeply through the patellar tendon. Once the patella was surrounded, the pretied knot of the cerclage was tensioned by the tensioner applying a force up to 80 pounds. The obtained reduction was checked under fluoroscopy; when satisfactory, three alternating half-hitches were tied with the aid of the tensioner, always applying a force up to 80 pounds to each one. The remaining suture tape was then cut. At the end of the surgery, standardised anteroposterior (AP) and lateral radiographs of the knee (in full extension) were obtained in the operating room.

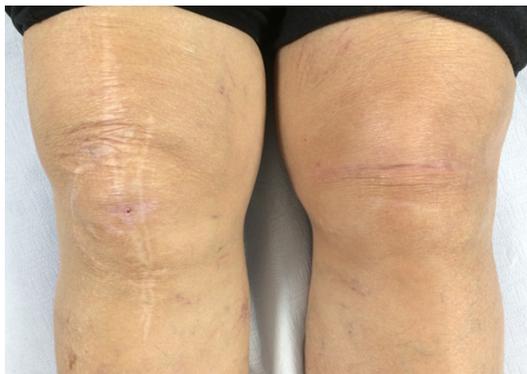
Figure 4. Surgical scars appearance at six months follow-up of both knees of the patient.

and stiffness 82.14%, pain 88.9%, function and daily living 91.2%, function, sports and recreational activities 40% and quality of life 87.5%. At this time, she achieved a range of motion of 0-120°, and she could walk without pain and had no discomfort of the left knee. The surgical scar was completely healed with no complications (**Figure 4**).
